Carden Water Systems

Case Study

LANDFILL LEACHATE

Trip Report Landfill Site-Houston, Texas

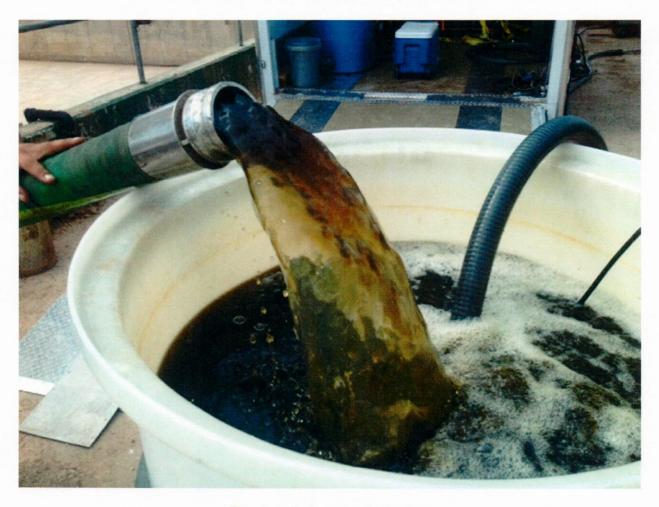
Raw Leachate ready for testing

Set up and testing operations began at 10:30 AM. CARDEN was provided 6 complete sets of sample coolers from Test America. Samples taken. Feed water from the leachate equalization tank was very dark in color with a viscosity equivalent to antifreeze. Leachate feed water pressure for the Nano/Ultra Membrane assembly was 120 PSI. Reject water was flowing at the rate of 2 GPM. Combined permeate flow was unmetered but estimated at 30 gallons per minute.

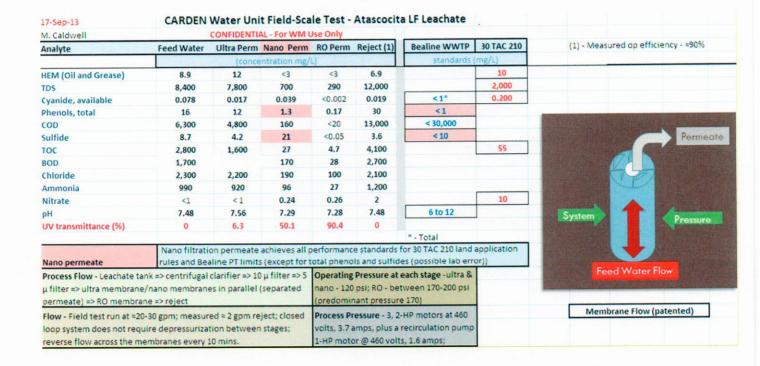
Analytical Testing Results of Untreated Leachate
